TECHNICAL REPORT NO. 11850

APPLICATION TECHNIQUES
AND
METHODS FOR APPLYING FUSED
CARBIDES ON NON-LUBRICATED
WEAR SURFACES FOR HIGH VOLUME PRODUCTION

U. S. ARMY TANK-AUTOMOTIVE COMMAND
CONTRACT NO. DAAE07-71-C-0148
MM&T PROJECT NO. 4704287

VEHICULAR COMPONENTS & MATERIALS LABORATORY

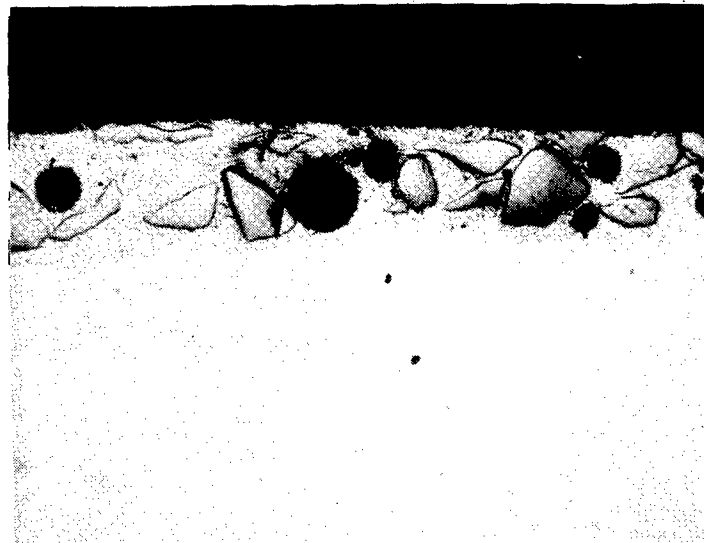
Figure 6

Code "N" Unetched
50X

This shows the massive carbides plus extensive gas porosity.
